FINAL REPORT
DECEMBER 1992

REPORT NO. 91-14

WOODEN BOX PALLET
MIL-STD-1660 TESTS

Prepared for:
U.S. Army Defense Ammunition
Center and School
ATTN: SMCAC-DES
Savanna, IL

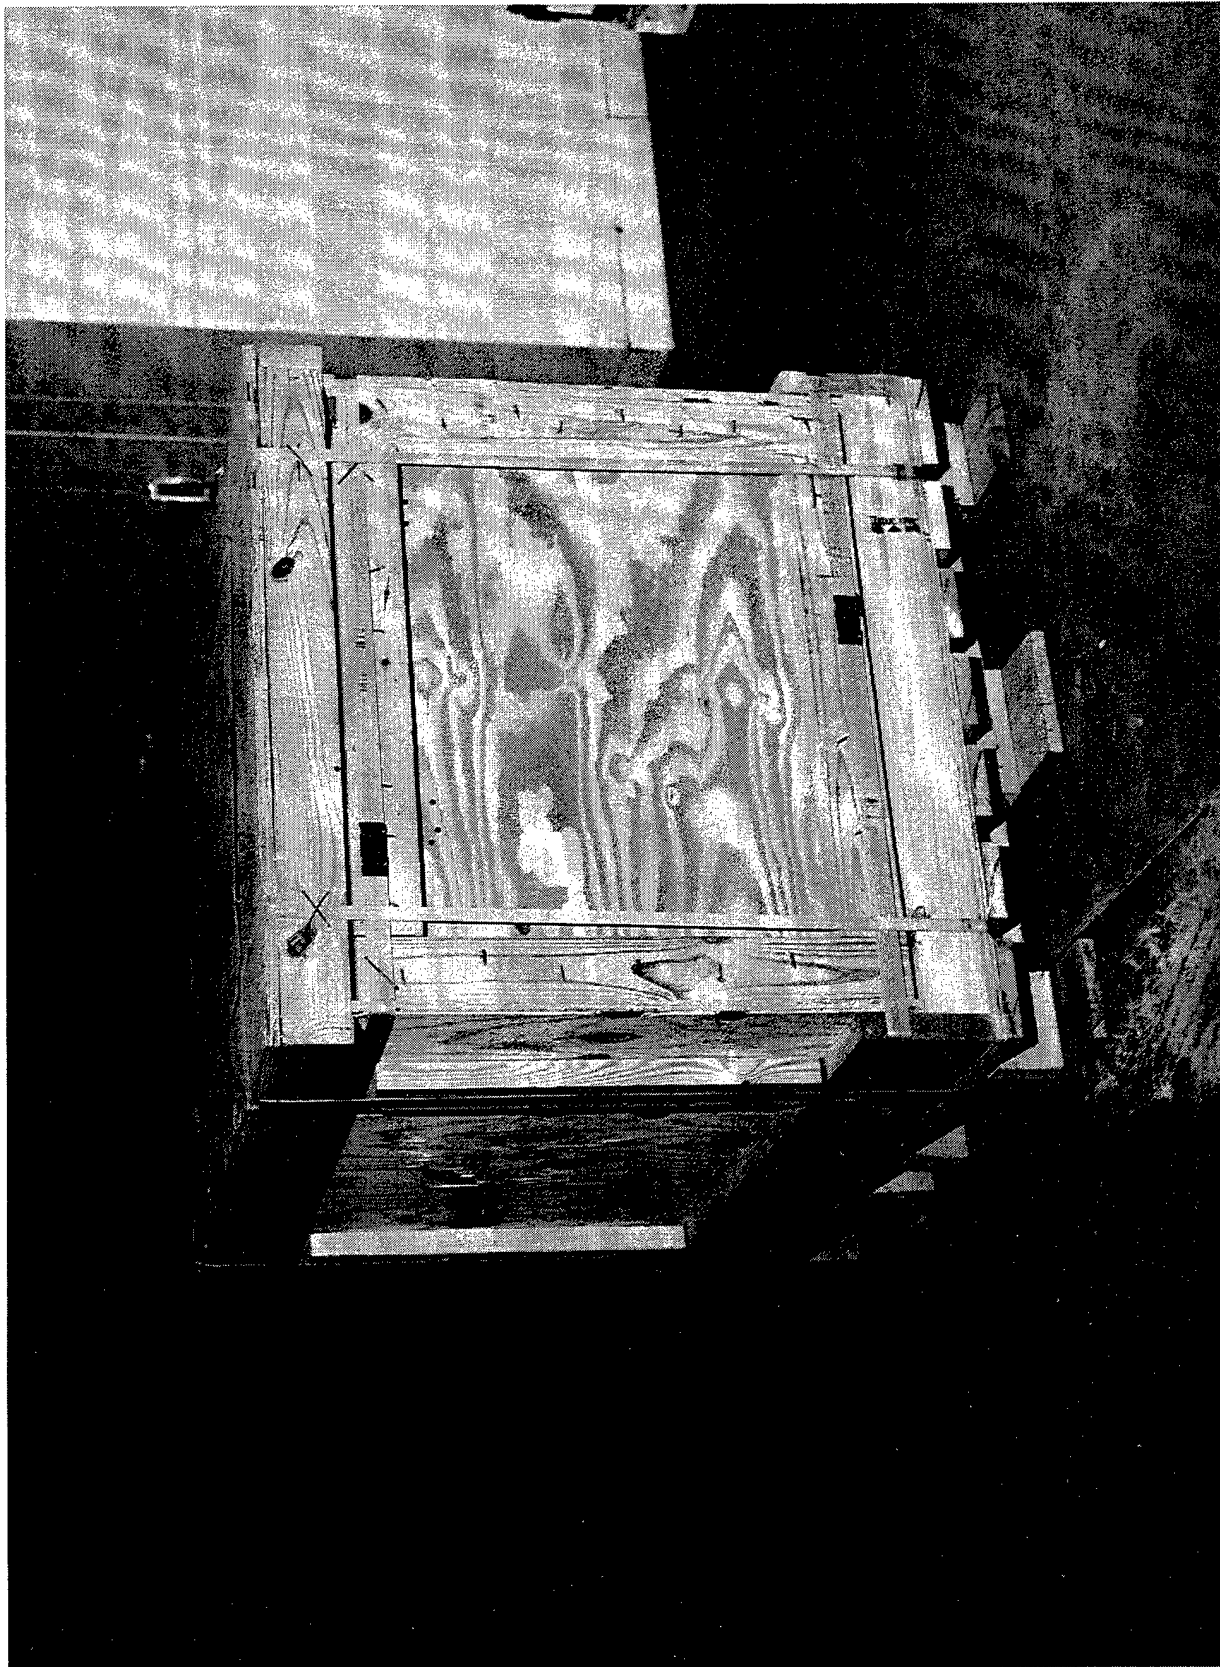
| AO317-SCN-96-123-2382. This photo shows the second test pallet following testing. Note the cracking on the side. | | |

5. END OF TEST INSPECTION. During final inspection, slight cracking was noted on one side. The cracking was minor as it was only superficial.

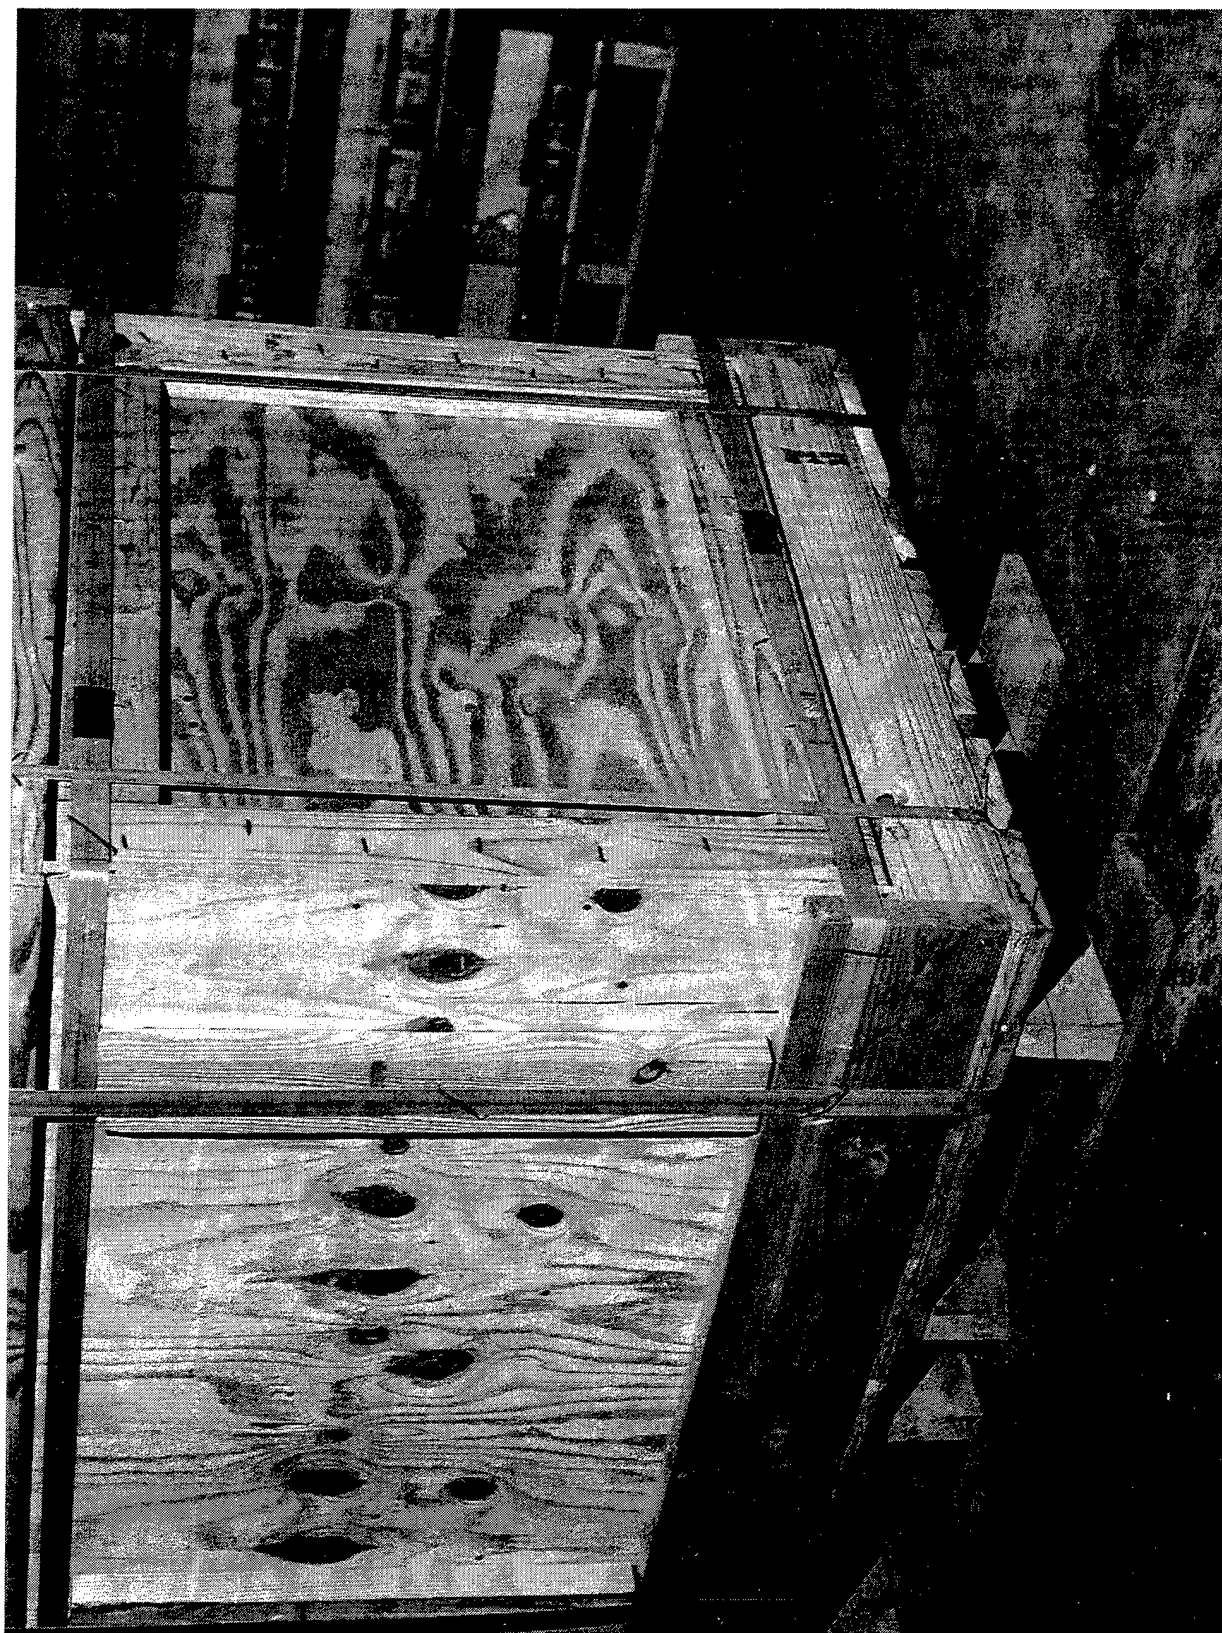
| | AO317-SCN-96-123-2383. This photo shows the damaged side of the second pallet. Note the broken band and cracking of the rear plywood face. | |

2. REPETITIVE SHOCK TEST. The duration of the test was 90 minutes for each orientation of the pallet. In order to achieve the clearance between the pallet and the transportation simulator bed, the equipment was operated at 210 rpm for the lateral orientation. One 1-1/4-inch band broke and the other 1-1/4-inch band cracked three-fourths of the way through from contact with a weld on the test equipment. This is not critical to the test since it was due to circumstances of the test. The pallet was then vibrated at 205 rpm for the longitudinal orientation. No other damage was noted.

3. EDGEWISE ROTATIONAL DROP TEST. Each side of the pallet base was placed on a beam displacing it 4-1/2-inches above the floor. The ends of the pallet were raised to a height of 24 inches, which is 12 inches higher than required. The process was repeated in a clockwise direction until all four sides of the pallet had been tested. The damaged band from the repetitive shock test broke during the first drop. Testing continued with no other damage.
